# Manhole Inspection Summary

Manhole # S21MM\_034MH

**Location** Address: **2602 WOODBROOK AVE**

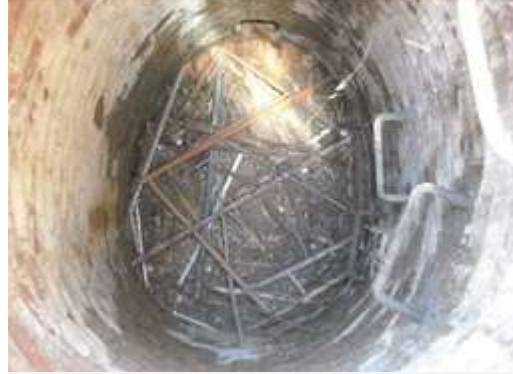
Top View

SUNLIGHT POINT TO THE PIPE OUT

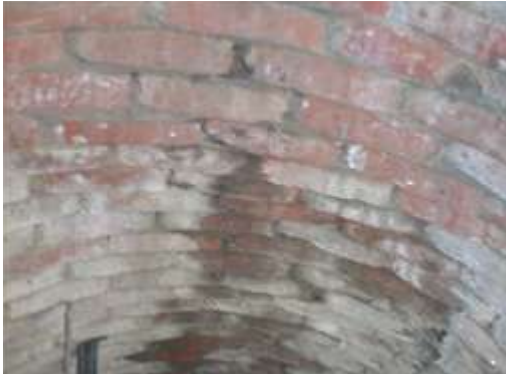
Defect 2

Infiltration: ☐ None ☐ Joint ☐ Cracks ☐ Mortar ☐ Roots ☒ **Wall**

INFILTRATION OF CORBEL

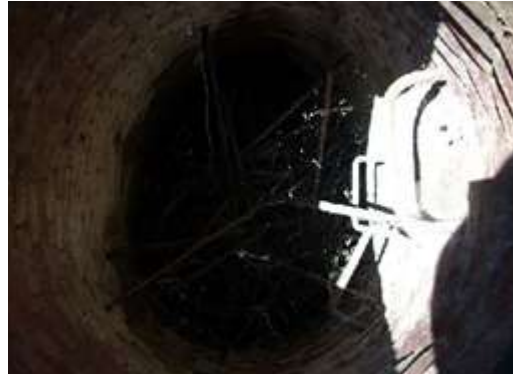
Defect 3

Condition: ☐ Sound ☐ Cracked ☐ Root Intrusion ☐ Deteriorated ☐ Leaks ☒ **Debris**

ALOT OF DEBRIS IN CHANNEL

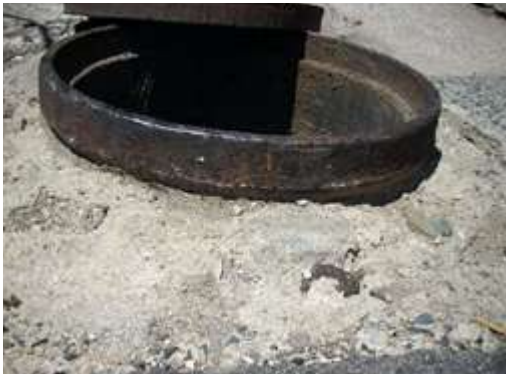
Defect 1

Diameter: **24** (in.) Length: (in.) Dist A/B Grade: **4** (in.)

GRADE ADJ. 4"

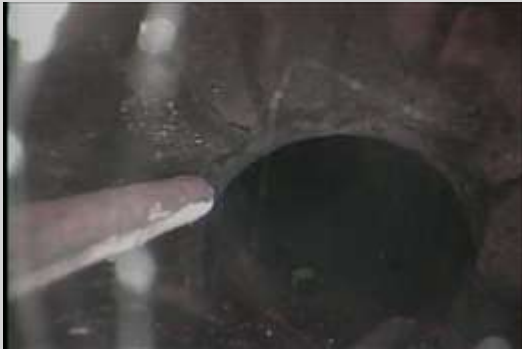
12 O'Clock Outflow

8 in. Circular Gravity Sewer  
Pipe Out @ 12 O'Clock

Deposits: ☐ None ☐ Mud ☐ Sludge ☒ **Debris** ☐ Grease

Silt Depth: **3** (in.) Deposits Extent: **Medium**
